**World Bank / Lake Chad Basin Commission**

**APPRAISAL OF THE SAFETY OF THE TIGA AND  
CHALLAWA GORGE DAMS, NIGERIA**

**March 2002**

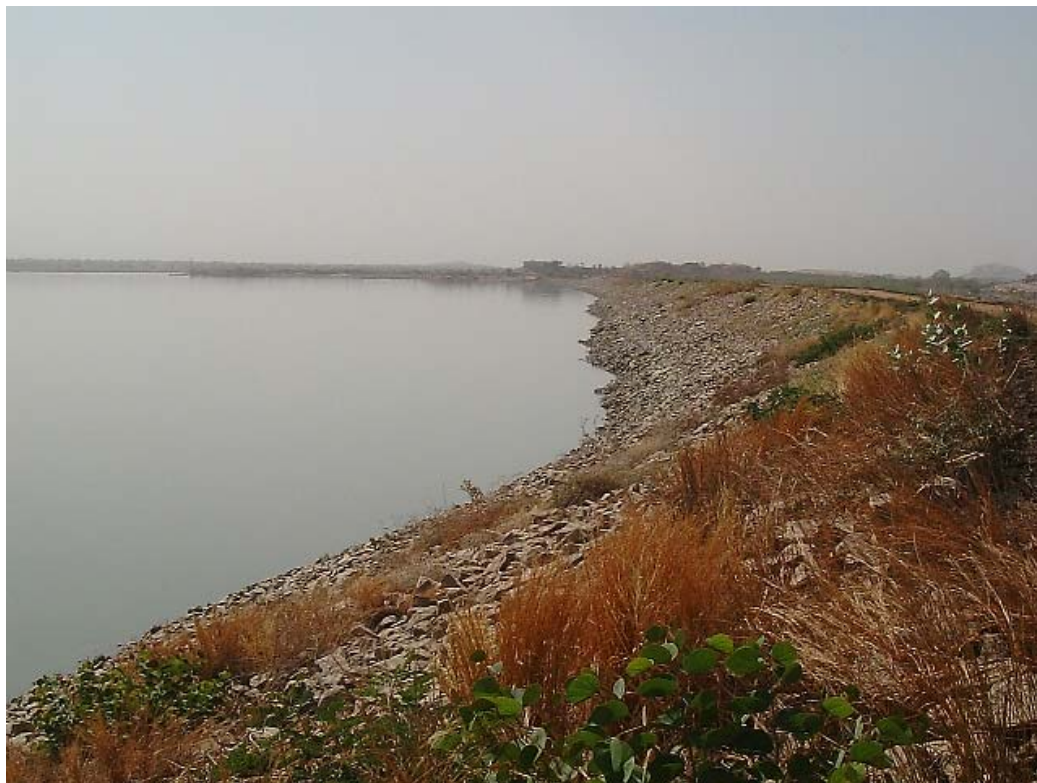
The upstream face of the dam is somewhat uneven as evidenced by an erratic shore line, as shown in the photograph: this observation tends to support poor construction control as suggested in the Haskoning report<sup>2</sup> although it could be a manifestation of post construction settlement due to poor compaction, which is also noted by Haskoning.

The upstream face is protected from wave attack by riprap which appeared, at the points where it was inspected, to have been dumped. As dumped riprap the average stone size is undoubtedly too small, as noted by the USBR team<sup>3</sup>. However the Haskoning report contains construction photographs in which the riprap was being placed by hand, a technique in which smaller stone sizes can be tolerated. It is quite possible that the smaller stone specified for hand placing was retained even though the method of placing was changed, presumably to speed progress. The consequence of inadequate stone size is of course higher maintenance costs. In addition there is a considerable amount of weed growth through the riprap layer which will further reduce its effectiveness in dissipating wave energy.

**Upstream face of Tiga dam, looking west**

As has been noted the stone size of the riprap is inadequate to protect the wave erosion. The replacement of the riprap layer, especially at the higher levels, would be very desirable but is probably unrealistic in the short term. It is particularly necessary therefore that the riprap is subject to annual inspections and remedial works where necessary to repair any damage.
