**Okavango River Basin: Transboundary
Diagnostic Analysis Project:
Environmental Flow Assessment Module
Specialist Report
Country: Namibia
Discipline: Geomorphology**

February 2009

Specialist Report: Geomorphology Country: Namibia

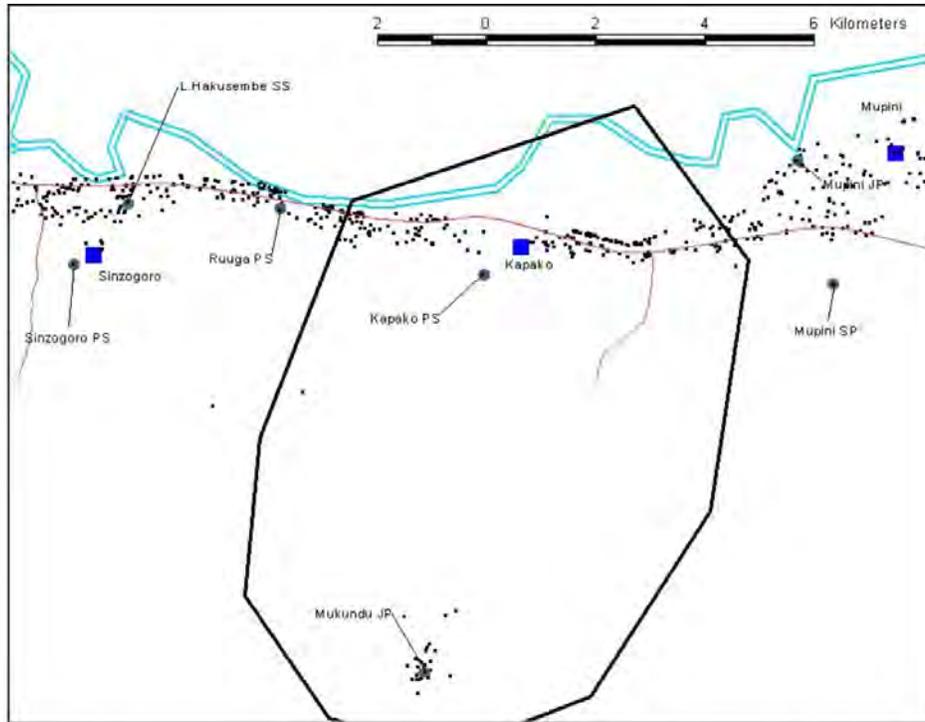
Figure 2. 3: Kapako Village

Figure 2.3 Site 4: Kapako showing the village of Kapako, the main road and surrounding settlements in relation to the river. Most of the area between the road and the river is floodplain. The border shows the

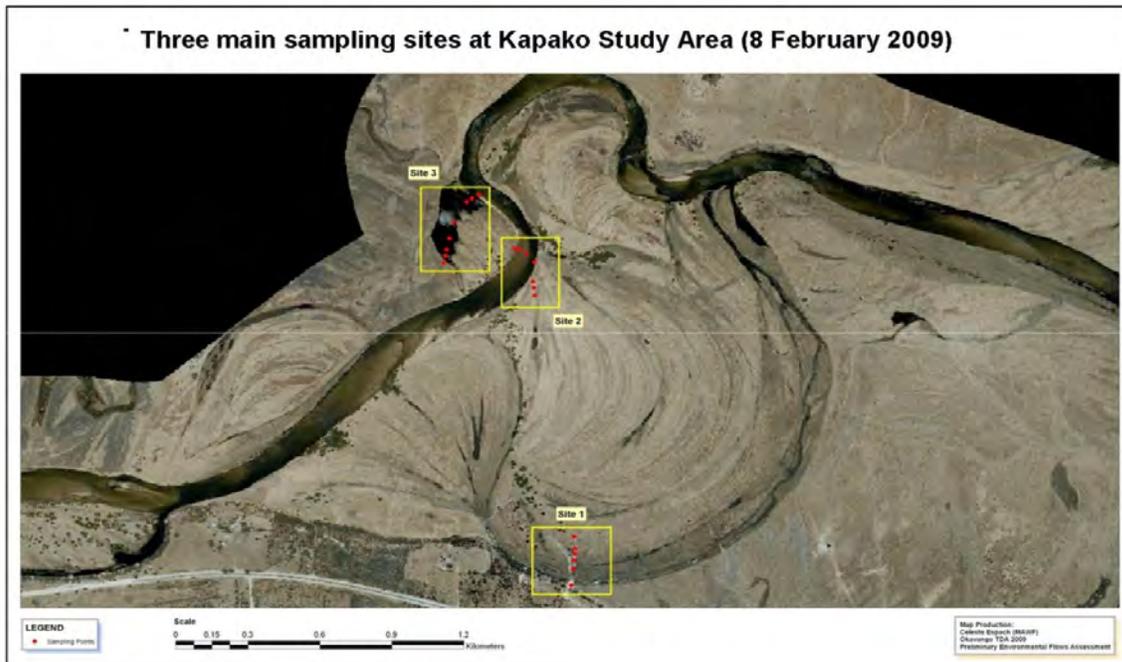
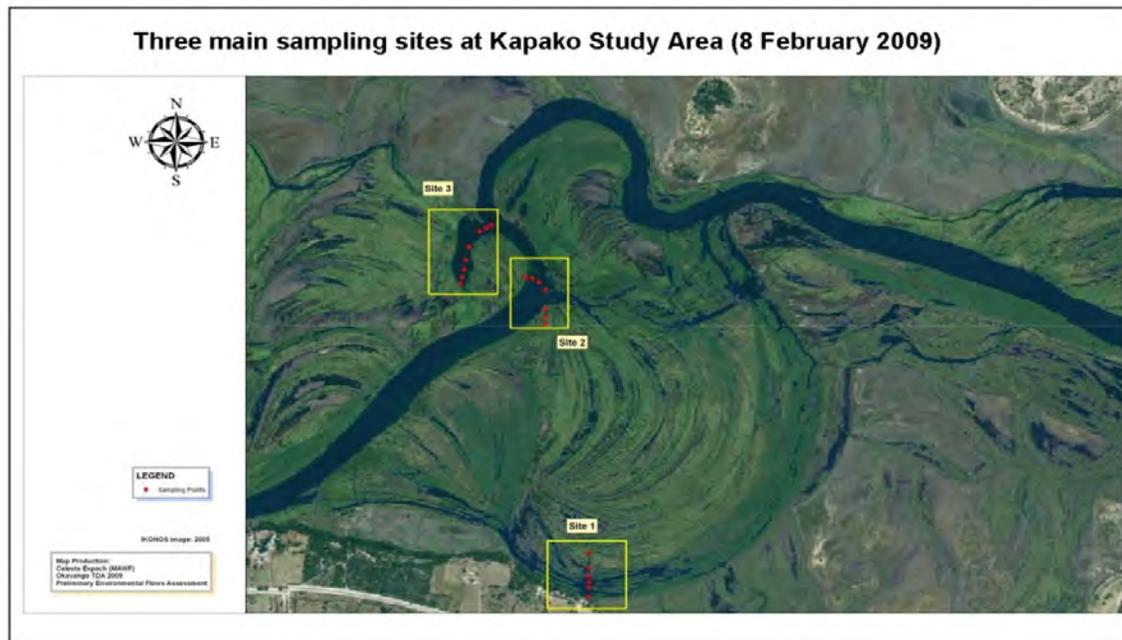
Figure 2.4 shows two satellite images of the Kapako floodplain Site 4. one in the dry season and one in the wet season. **Figure 2. 4: Satellite images of the Kapako Flood Plain**

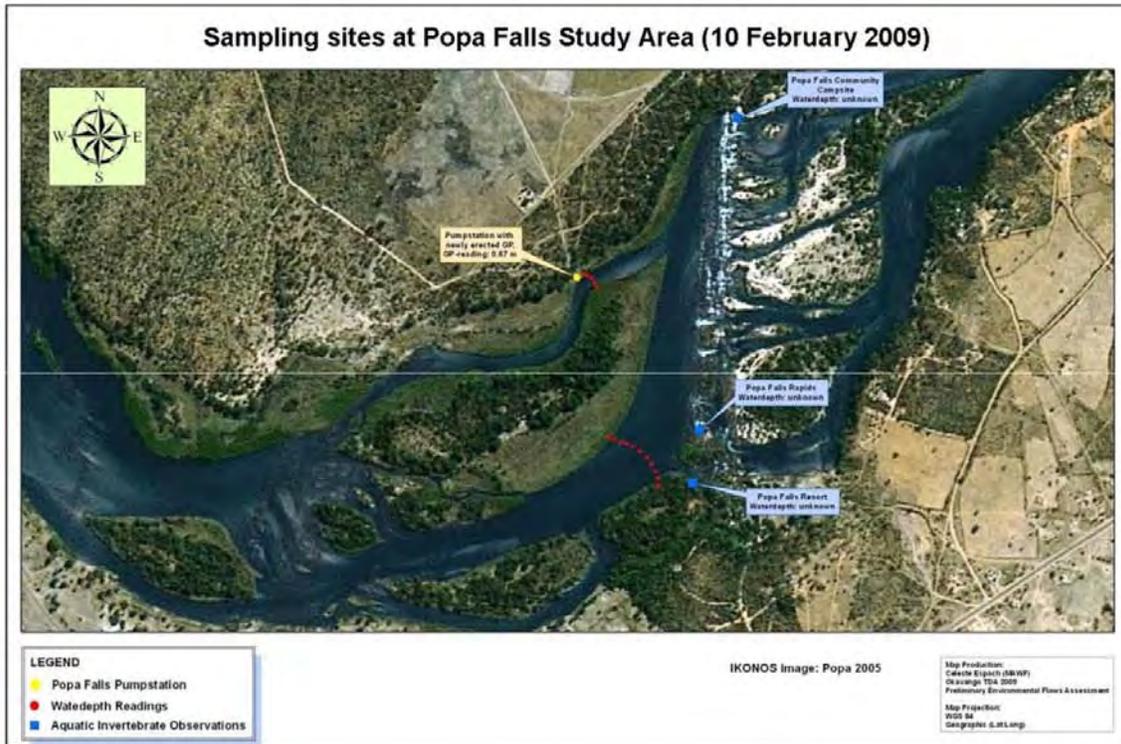
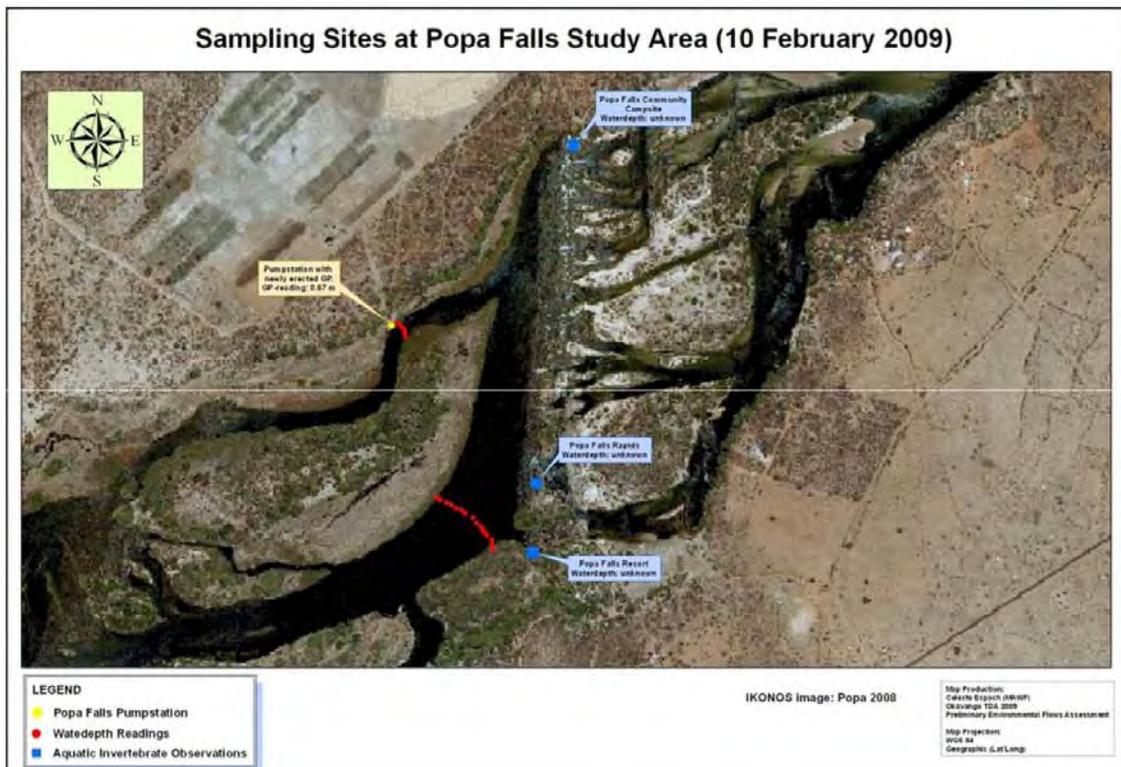
Figure 2. 6: Satellite image of Popa Falls showing wet and dry transects and main sampling sites

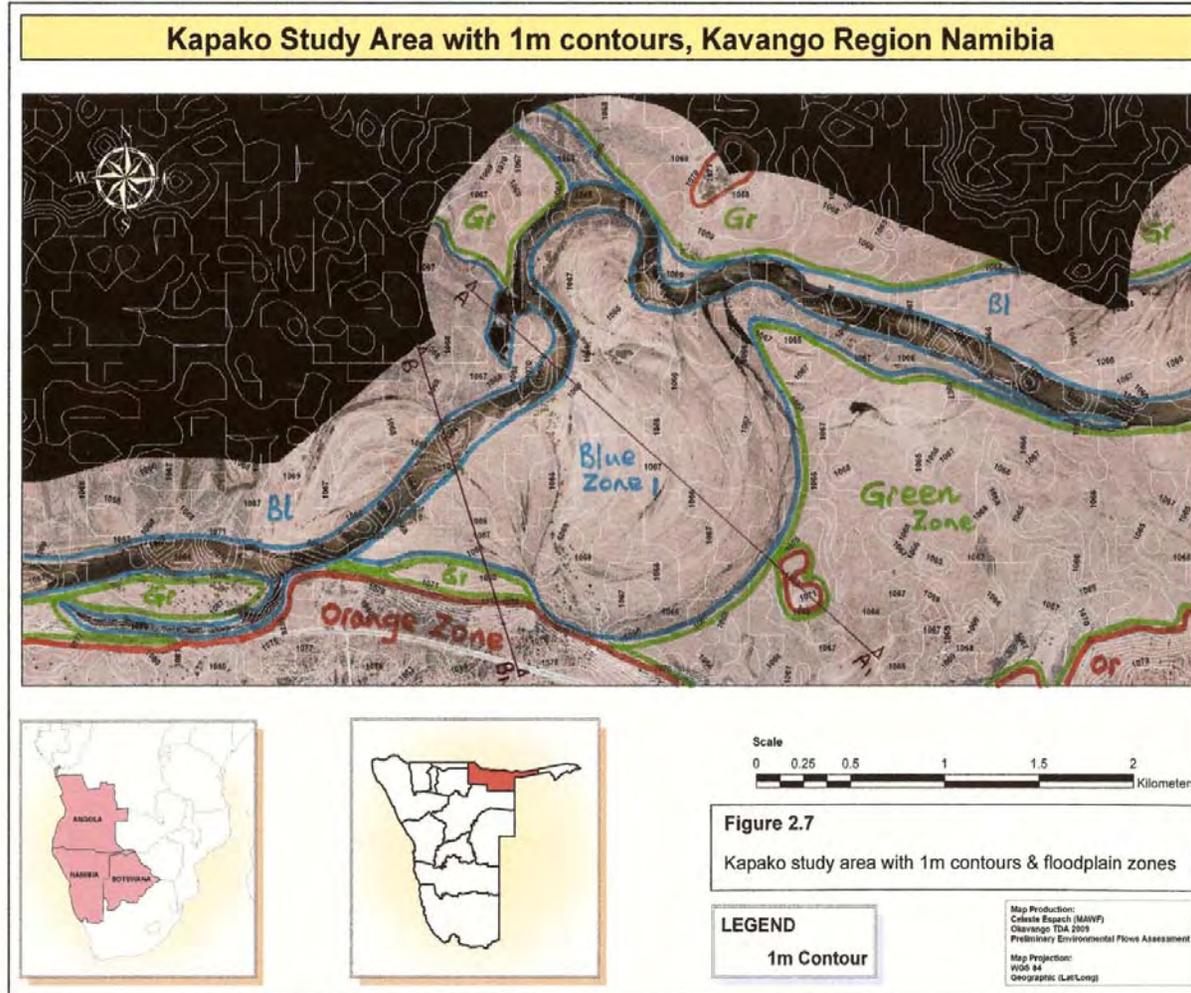
Figure 2.7: Kapako Map with Countours

Figure 2.8 shows two schematic Cross Sections through the floodplains. The location of these cross sections is shown in Figure 2.7 by the lines marked A – A1 and B -B1.

From west to east in Figure 2.7, these are found at the following locations:

- A. A long backwater is found at the base of the dry bank in the south west of the map. Its area is estimated at approximately 50,000 m².
- B. A deep backwater is adjacent to the upstream side of the oxbow loop. This is of particular interest due to the process of sedimentation that is in progress, which will be discussed later in this section. The area is estimated at 36,000 m², and the maximum depth was measured at 4m.

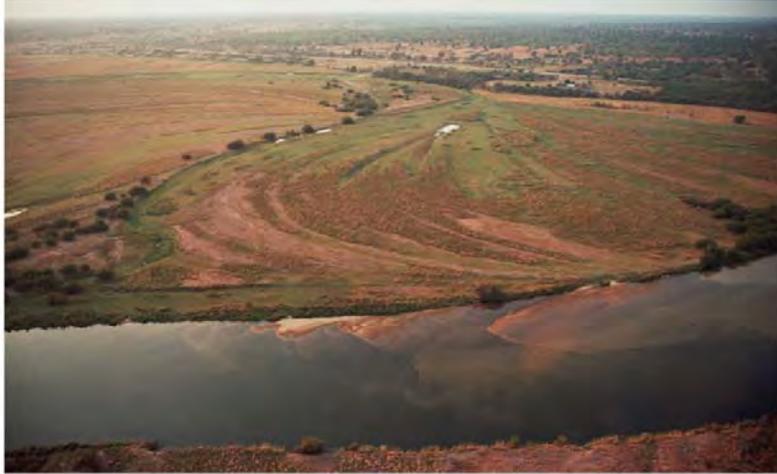
Photo 1: Aerial view of the western part of Kapako floodplain from the Angolan side looking southwards (low flow, October 2006). When the water overflows its banks, it deposits large amounts of sand in the channel due to reduced flow velocity. As seen here, however, most of the resulting sandbars are not normally exposed. A few pools on the active floodplain remain throughout the year. The dry banks are indicated by the tree line in the background.

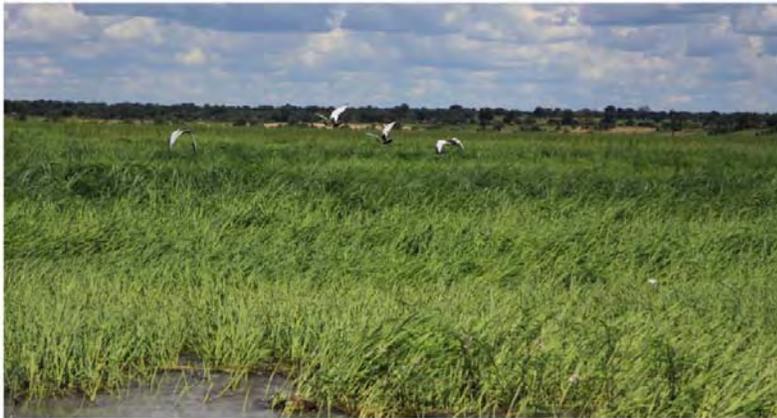
Photo 2: A view from the main channel south-eastwards over Blue Zone 1. In the background the dry banks are shown, covered with trees and bush except where they are disturbed by cultivation – note the bare patches at the base. In the foreground the water is flowing about 0,5m deep out of the main channel and into a grassy floodplain.

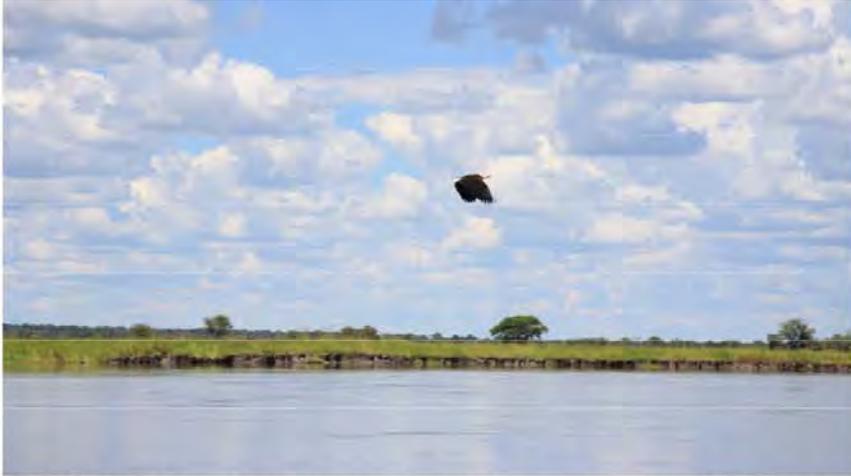
Photo 4: Floodplain in Angola, with dry banks in the distance covered with woodland.

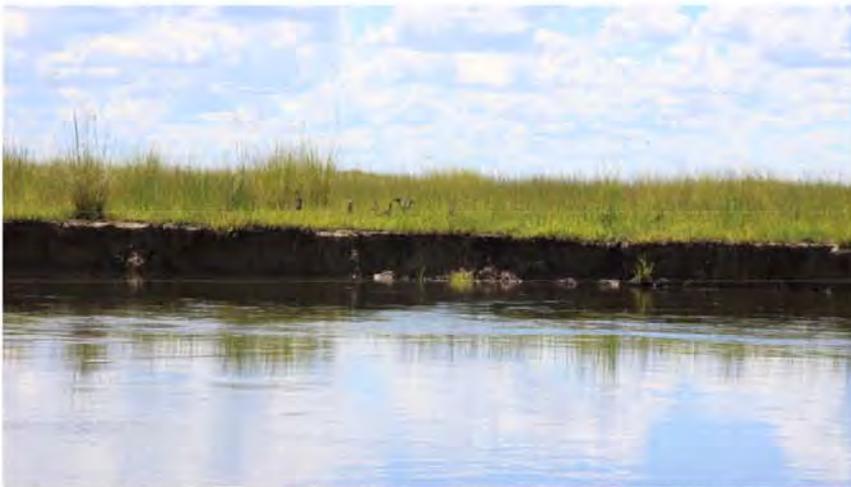
Photo 5: Green zone, active erosion of banks on the outside of the oxbow loop.

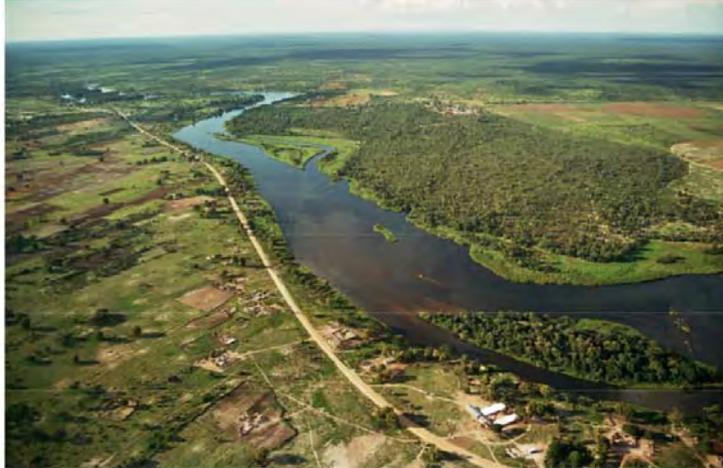
Photo 7: A view northwards up the Okavango River towards Divundu and beyond. The trans Caprivi road runs left-right in the background. Popa Falls is out of the frame to the right. The photo was taken during the high flow season in 2003.

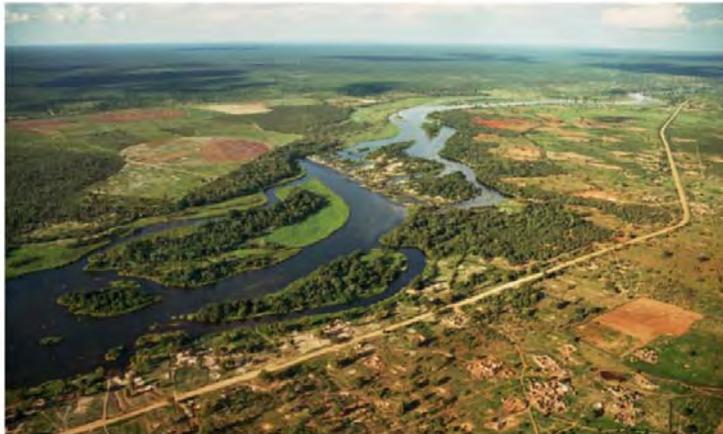
Photo 8: A view down the river showing Popa Falls at the centre. The road to Mohembo runs to the right. High flow season in 2003.

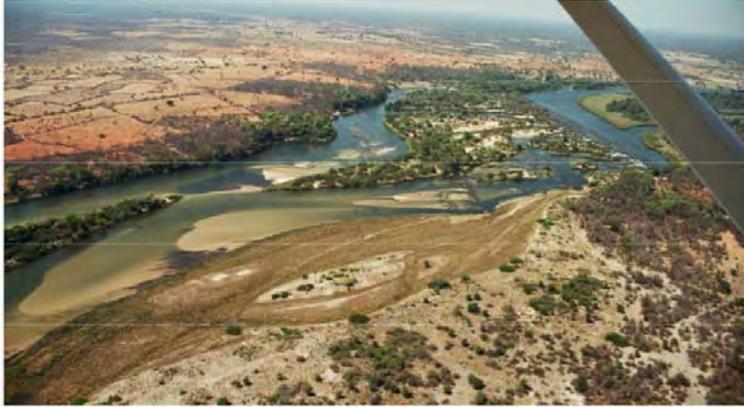
Photo 10: This view to the south over Popa Falls shows submerged sandbars below the falls. Organic matter (dark "shadows") has accumulated on the downstream side of the bedforms. October 2002.

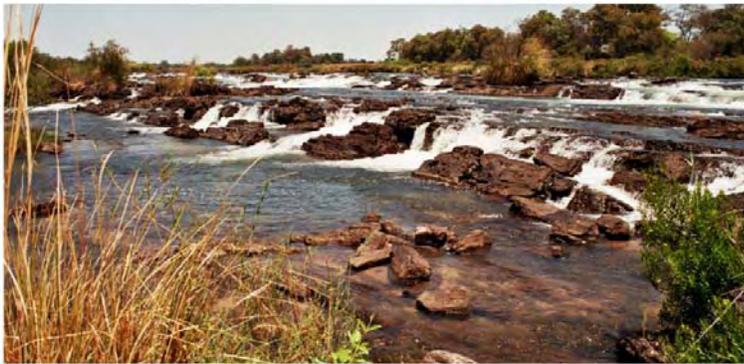
Photo 11: The foot of Popa Falls on the north bank in October 2002 – low flow.

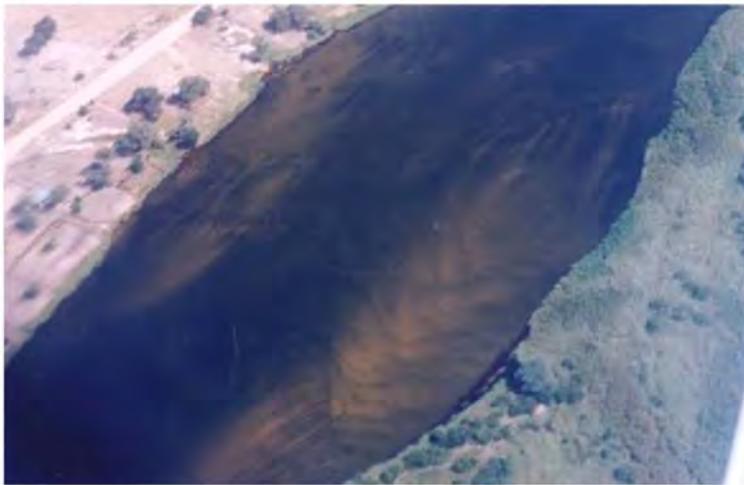
Photo 12: Bedload transport is demonstrated here downstream of Divundu Bridge two weeks after the flood peak in April 2003. The sand is stirred up around rocks due to locally higher velocities, but within 100m it settles out into bedforms and proceeds to move as bedload. The photo shows clearly that the dominant form of transport is bedload transport. Furthermore, the fact that the bed (at 3 –

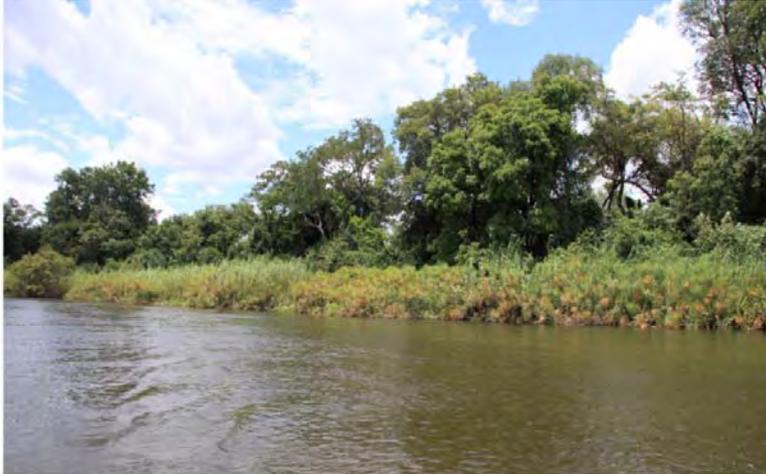
Photo 13: A view of the largest island above the falls from the northern-most channel. Fringing reeds and papyrus protect this island from erosion. February, 2009.

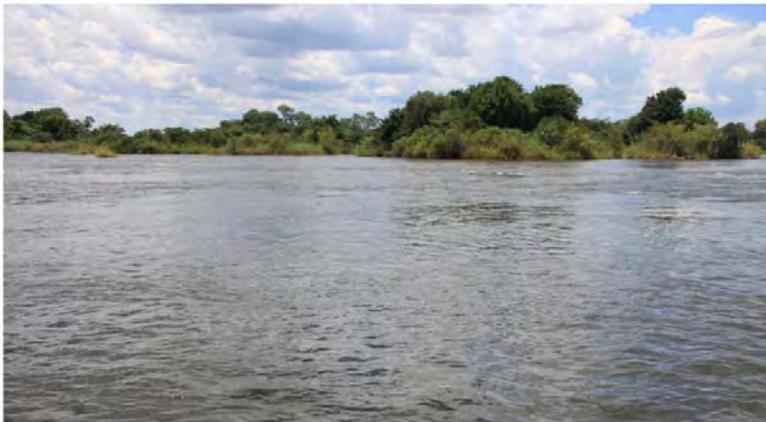
Photo 14: The islands above Popa Falls viewed from upstream of them. Riffles in the mid-right are largely covered in these high flow conditions - February, 2009.

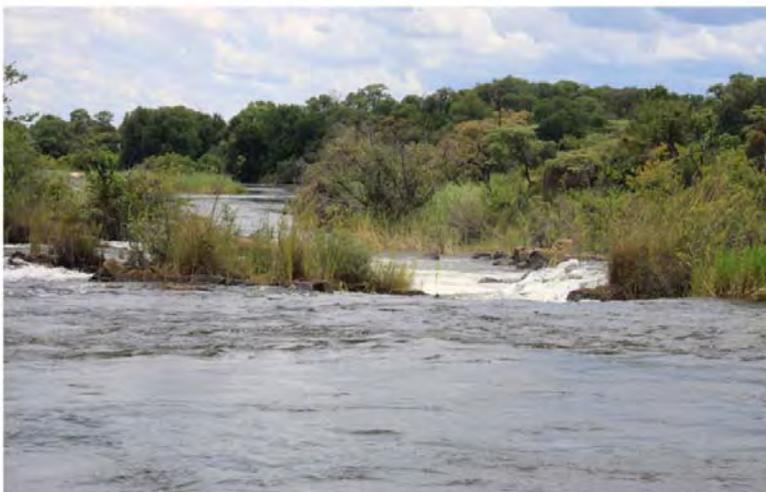
Photo 15: A view down Popa Falls on the south side. The drop varies from

Photos 9 and 15 show that the islands have a base of bedrock. Other photos by Mark Paxton during low flow conditions in October and November 2008 confirm this observation (not included in this report).

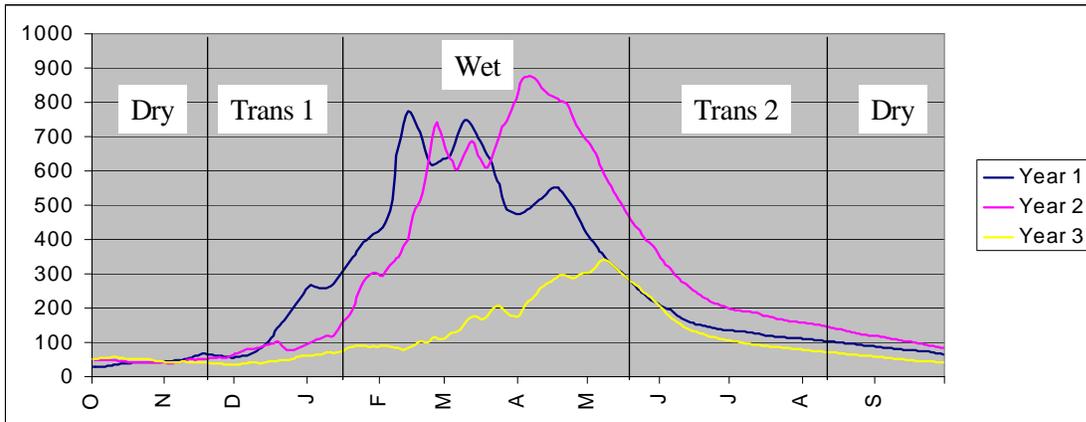
Figure 3. 1: Three representative years for Site 4: Okavango River at Kapako (hydrological data from Rundu), illustrating the approximate division of the flow regime into four flow seasons

Tentative seasonal divisions for river Sites 4 and 5 are shown in Figure 3.1 and 3.2. These seasonal divisions were formalised by the project hydrological team in the form of hydrological rules in the hydrological model. In the interim they provide useful insights into the flow regime of the river system. Figure 3.1 shows the flow of the Cubango / Okavango River at Rundu (just downstream from Kapako). Figure 3.2 shows the flow of the Okavango River downstream from the confluence with its major tributary the Cuito River.

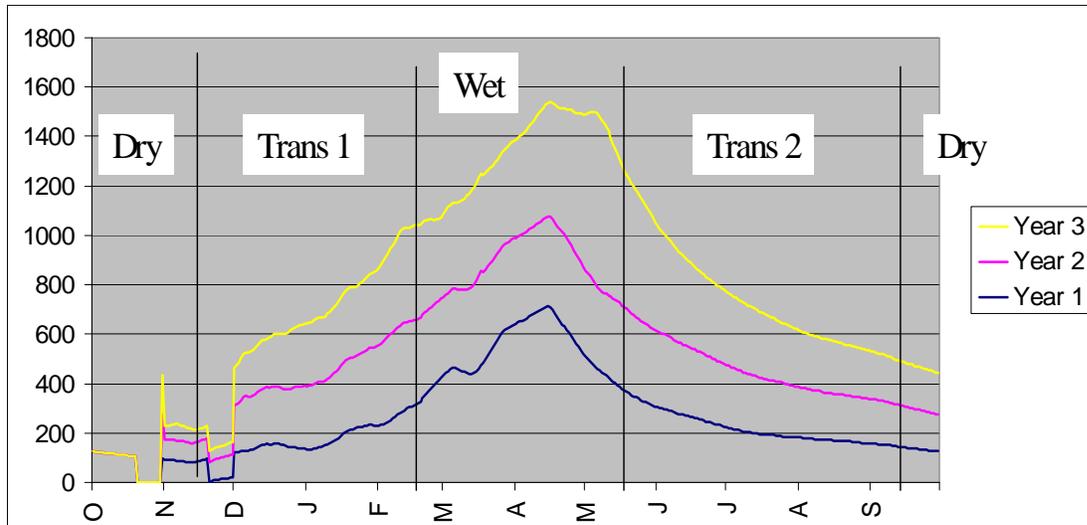
Figure 3. 2: Three representative years for Site 5: Okavango River at Popa (hydrological data from Mukwe), illustrating the approximate division of the flow regime into four flow seasons

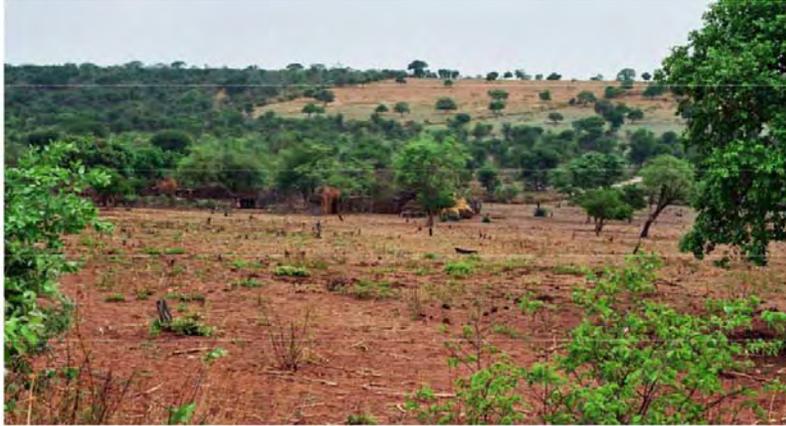
Photo 16: Kalahari palaeo-dunes are colonised by Kalahari woodlands until cleared for cultivation. Note the reddish coloured soils.

Outside of the dry banks of the River, the Kalahari dunes are/were covered dry Kalahari Woodland. This woodland receives its water by rainfall only and is drought-deciduous. The fine sand here is often reddish in colour due to coating of the sand grains with a little iron oxide (refer **Photos 16 & 17**).

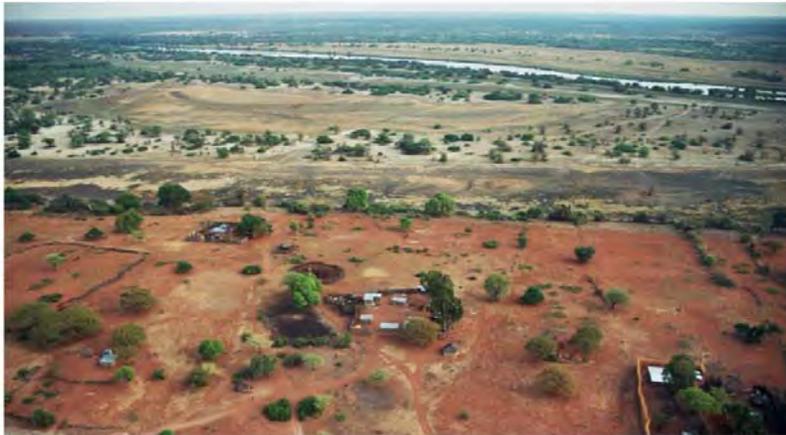
Photo 17: Soils outside the dry bank are reddish, compared to floodplain soils, which are whitish because the iron oxide coating on the quartz sand grains has been reduced by contact with water.

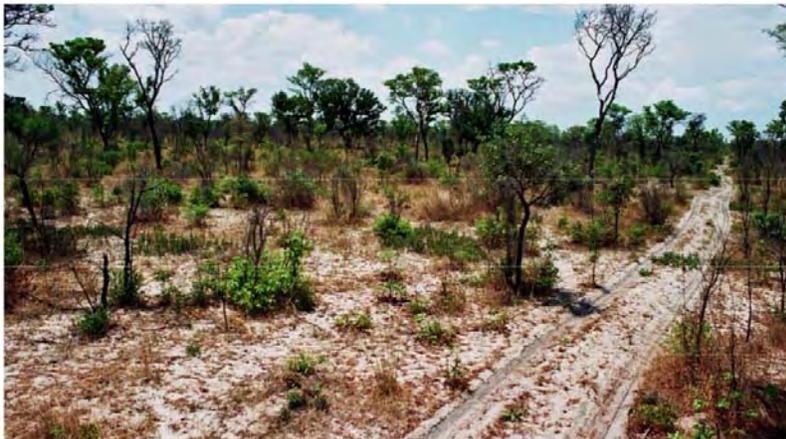
Photo 18: Soil in woodlands may also be whitish, but it also originates from Kalahari dunes.

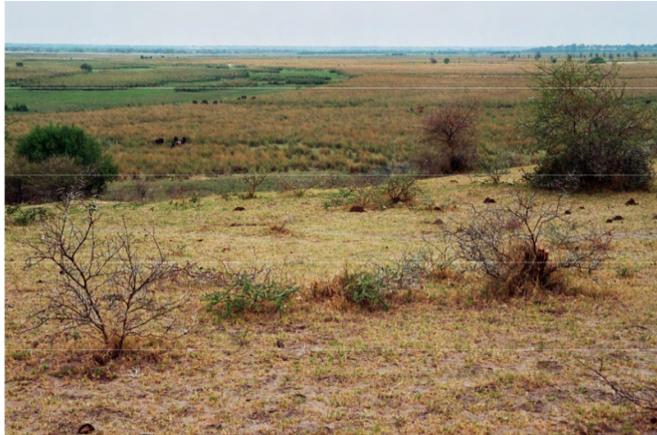
Photo 19: Floodplains support hygrophilous grasses, reeds and sedges where trees cannot grow due to long periods of inundation. On floodplains clay particles in the soil are replenished during flooding. Deposition is encouraged by the vegetation.

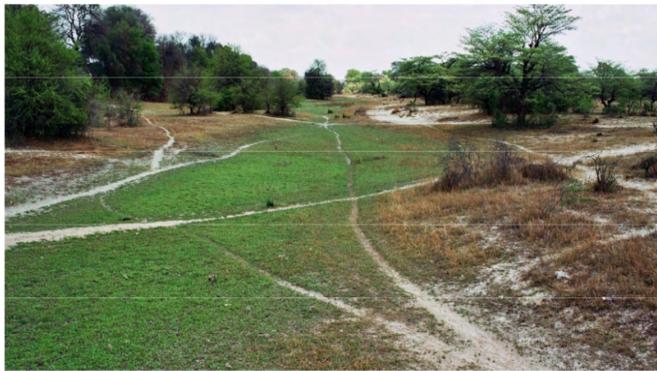
Photo 20: Omurambas may be inundated for weeks or months during the wet season. Only grasses (in this case) or wetland vegetation can grow in these conditions.

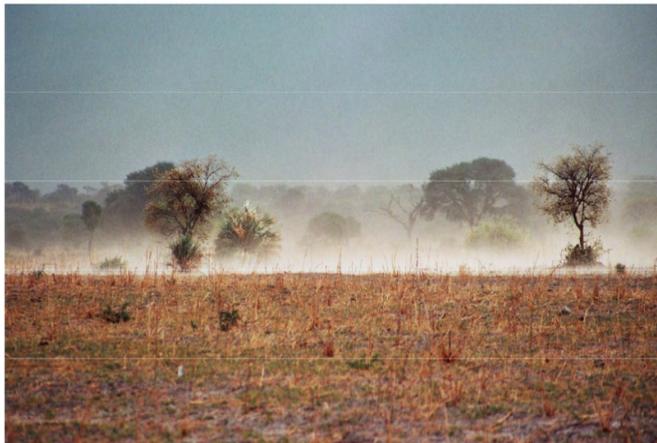
Photo 21: Cultivation exposes soils to wind erosion. Especially during the hot dry months in spring, dust storms result as the fine particles are removed from the soils.

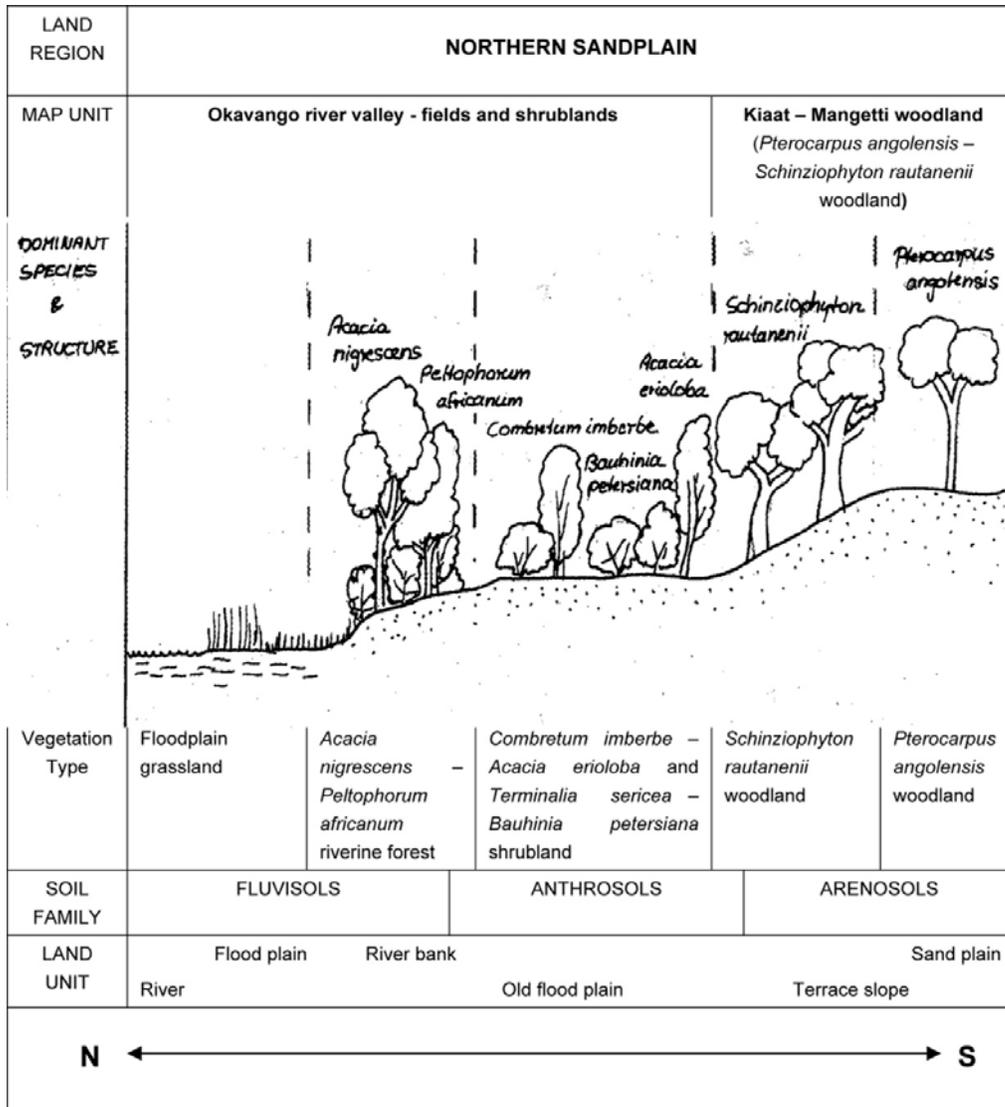
Figure 4. 1: Schematic diagram (not to scale) of *Pterocarpus angolensis* – *Schinziophyton Rautanenii* woodland and associated soil families on the floodplain and terrace system of the Okavango River.

Floodplain, river bank, old flood plain (terrace) and terrace slope comprise the main sequences of landforms bordering the Kavango River. Grasslands with species such as *Vossia cuspidata*, *Cynodon dactylon* and *Setaria sphacelata* dominate the floodplain, while riverbanks originally supported riverine forests with *Acacia nigrescens*, *Peltophorum africanum* and *Diospyros mespiliformis* as dominant trees and a dense shrub undergrowth of various species. However, due to intense clearing and cultivation along the river, riverine forest has disappeared almost entirely and only few, localised patches remain. Today's river banks and terrace present an open parkland with few trees, cultivated land and many villages in between. Remnants of shrubland with *Combretum imberbe*, *Acacia erioloba*, *Terminalia sericea* and *Bauhinia petersiana* indicate the potential vegetation types of former terraces. However, human impact has also resulted in an increase in shrubs, often on old farmland and may thus give a false indication of what may have occurred naturally on these old floodplain terraces.
