# GEF PACIFIC IWRM PROJECT RESULTS NOTE

## Improvement and Sustainable Management of Neiafu, Vava'u's Groundwater Resource

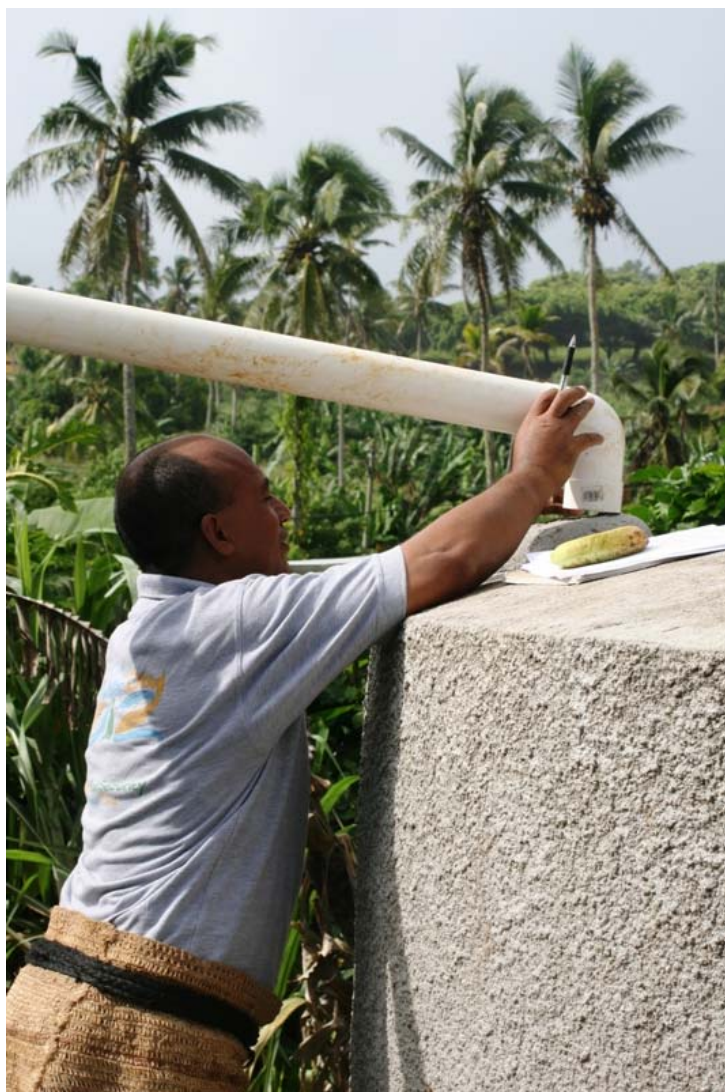
**Figure 1** Community Audits of Rainwater Tanks

Additional water leakage losses are being targeted by the project at the household level, with audits being undertaken to identify household losses and improve household water use efficiency. This work is being supplemented by trial household level treated wastewater reuse schemes.

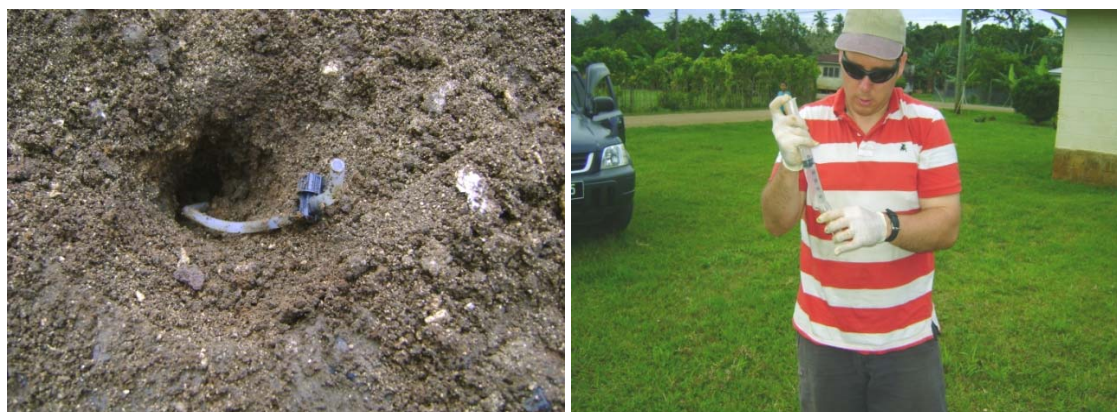
**Figures 8 and 9** Nutrient monitoring in to assess reduced nitrogen discharges to groundwater. Sampling site (left) and testing (right)

Prior to the project commencement, Neiafu had been without septic tank service facilities for many years, causing many of the town septic tanks to fail, creating unsanitary conditions around many tanks and dramatically increasing groundwater pollution. At the request of the Neiafu community, the project reestablished a septic pump-out management system. Households were surveyed to identify failing septic tanks and advice provided through a combination of media (television, radio and a school-based awareness competition). Trial sanitation systems have been installed to demonstrate reduced groundwater impacts, including sand filtration and compost toilets.

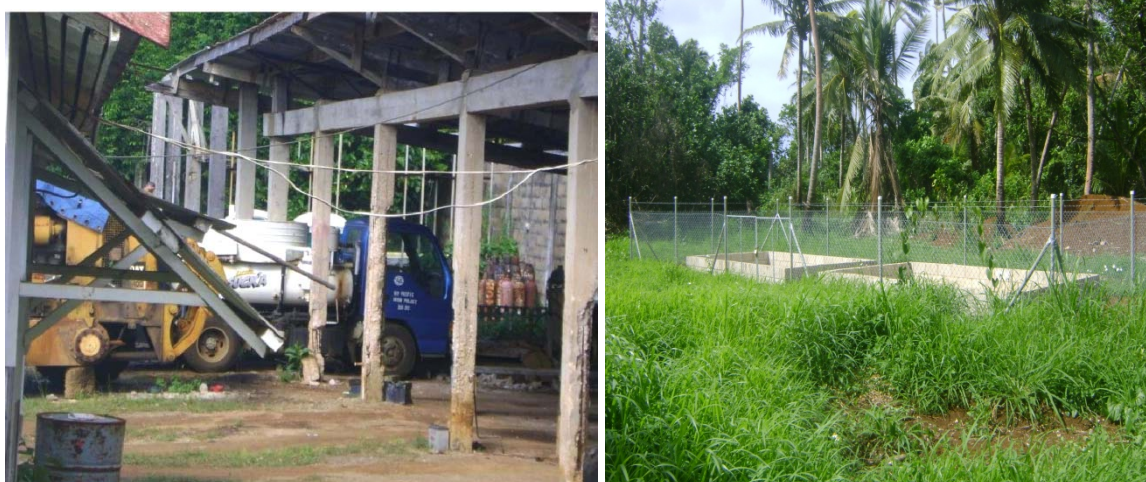
**Figures 10 and 11** Vacuum truck and sludge management beds at Kalaka Site

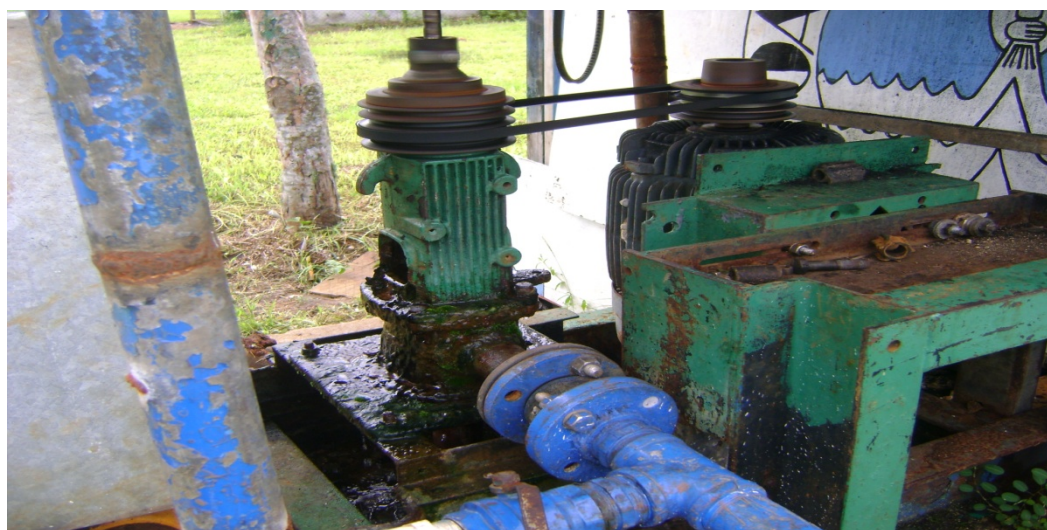
**Figure 12** Old infrastructure associated with 70% leakage losses. A key study suggest that old valves may be contributing significantly to losses

As part of the project an assessment on Neiafu Groundwater and sustainable management has been completed, which identified 70% water losses. This figure is much higher than previously anticipated and has focused thinking on cost-effective responses. The assessment concluded that the majority of water loss was attributable to failing old infrastructure, including leaking pipes and valves. The project is working in partnership with Tonga Water Board to reduce water leakage from the system through a combination of leak detection, targeted on-ground works and system management.

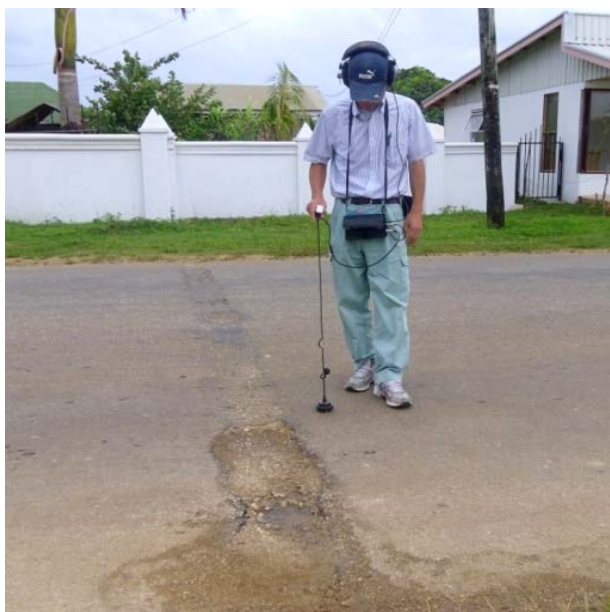
**Figure 13** Leak detection in Neiafu

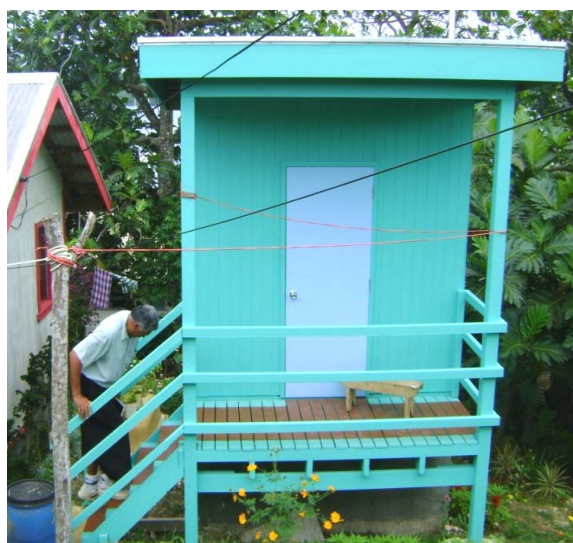
**Figure 14** Composting Toilet at Fungamisi

*A project survey identified that over 90% of Neiafu was operating failing sanitation systems. A further small percentage had no access to improved sanitation. Through the project, it has been possible to pilot the rehabilitation of ten failing systems, install two demonstration compost toilets and service the failing systems to ensure access to improved sustainable sanitation. Household level audits currently being developed will enable the Neiafu communities to ensure that all sanitation systems are functioning sustainably.*
